(NASA-CR-174411) CREEP-RUPTURE BEHAVIOR OF
IRON SUPERALLOYS IN HIGH-PRESSURE HYDROGEN
Quarterly Narrative Report, 7 Dec. 1982 - 28
Feb. 1983 (IIT Research Inst.) 44 p
HC A03/MF A01

CREEP-RUPTURE BEHAVIOR OF IRON SUPERALLOYS
IN HIGH-PRESSURE HYDROGEN

First Quarterly Narrative Report
for Period Covering 7 December 1982 to 28 February 1983

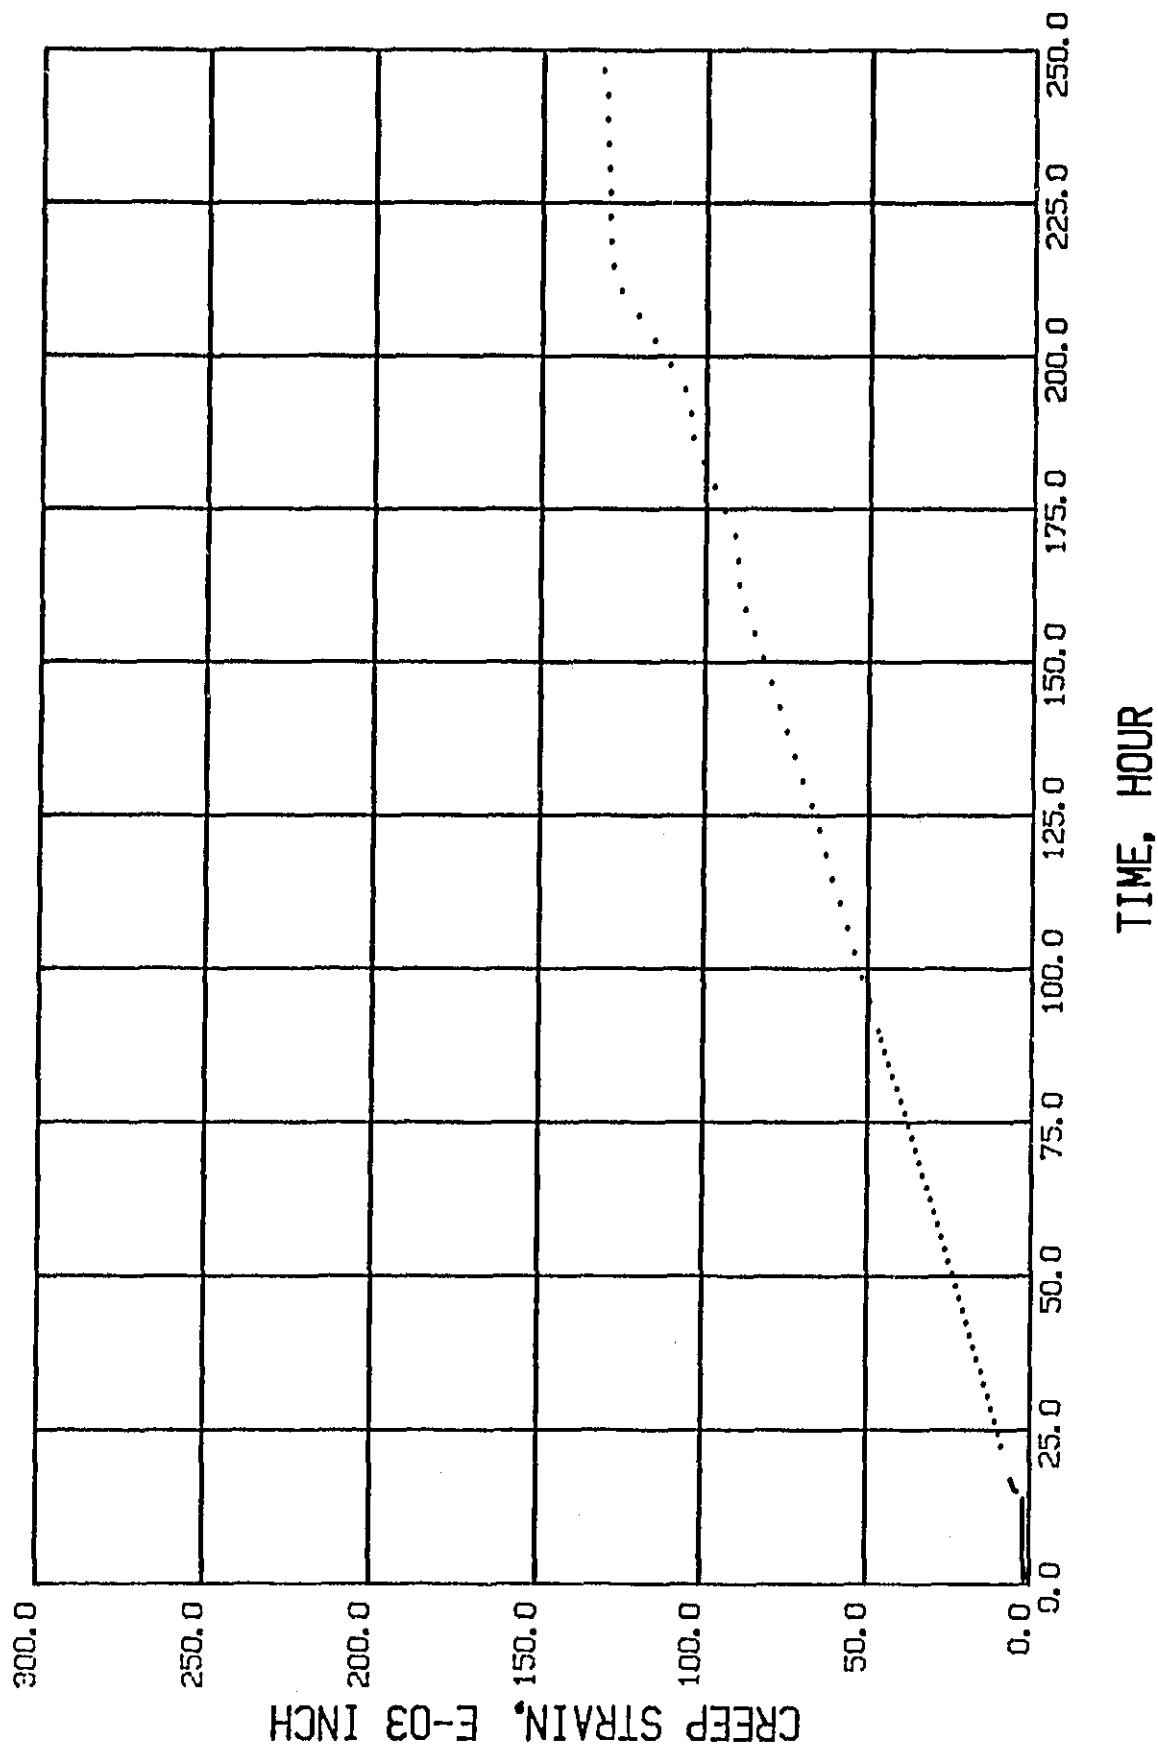
TEST H14 12RN72 760C./90MPa 15MPa H2

Figure 14. Creep strain-time curve for 12RN72 tested at 760°C in 15 MPa H₂ (rupture life, 247 h).

With the help of scale magnification, it is possible to obtain the time-strain plots to reveal details which will be difficult to obtain otherwise. Generally, after the first 1 or 1-1/2 h, the data collection is done every 4 h and, for test durations of 200 to 1000 h, a frequency of 4 h reveals the information within the desirable accuracy. A comparison of different scale magnifications through computer is shown for HS-31 data from test H14 in Figs. 15, 16, and 17. From Fig. 15, one can obtain the specific times to 0.1, 0.2, 0.5, 1.0, and 2.0% creep strains; Figs. 16 and 17 both permit a measure of the minimum creep rate, while Fig. 17 permits an accurate measure of the time to onset of tertiary creep. The plateau in Fig. 17 indicates the limiting range of the transducer where it got stuck and then jumped to a higher value on fracture. A careful examination of all the figures indicates that a fracture event has no effect on the creep behavior of the rest of the specimens (compare Figs. 6, 8, 10, and 12 for test H13, and Figs. 7, 9, 11, 13, and 14 for test H14).

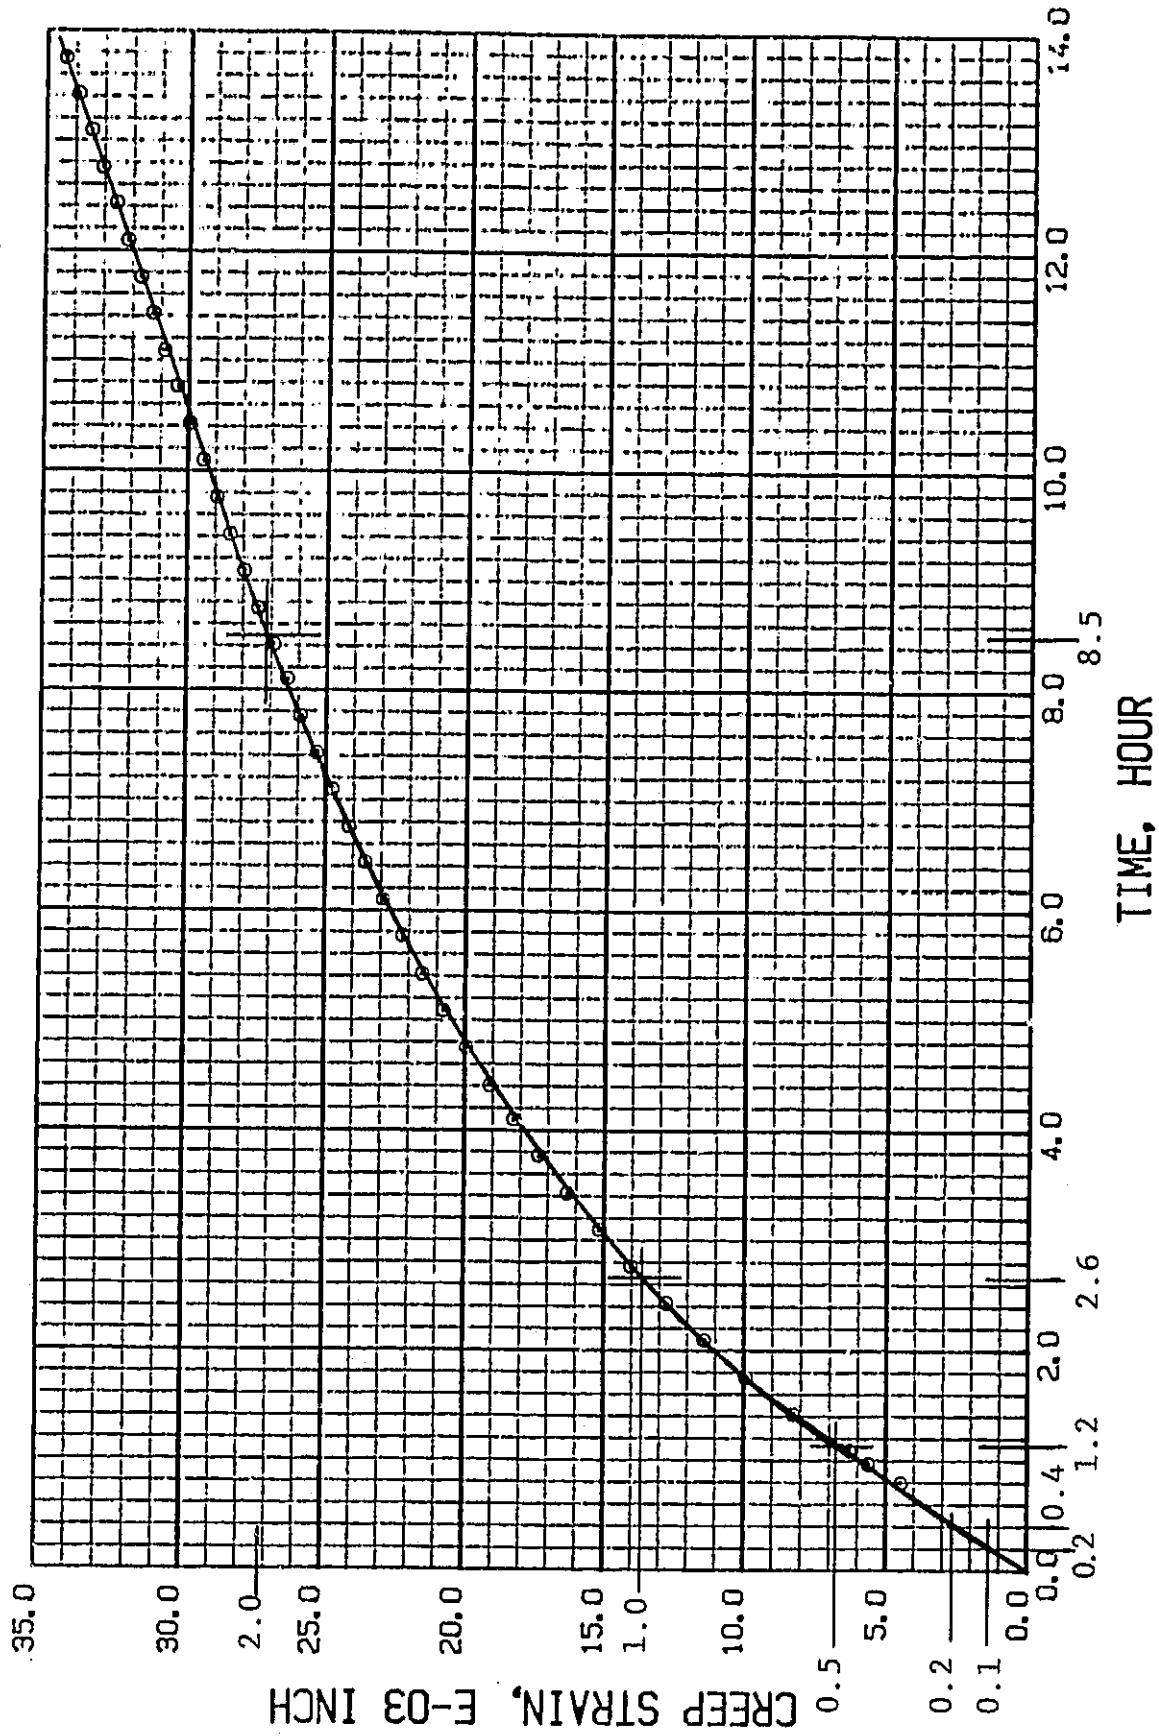
TEST H14 HS-31 760C./235MPa 15MPa H2

Figure 15. Creep strain-time curve for HS-31 tested at 760°C in 15 MPa H₂. Early part of the curve is shown for the evaluation of time (in hours) to reach specific creep elongations (in %).

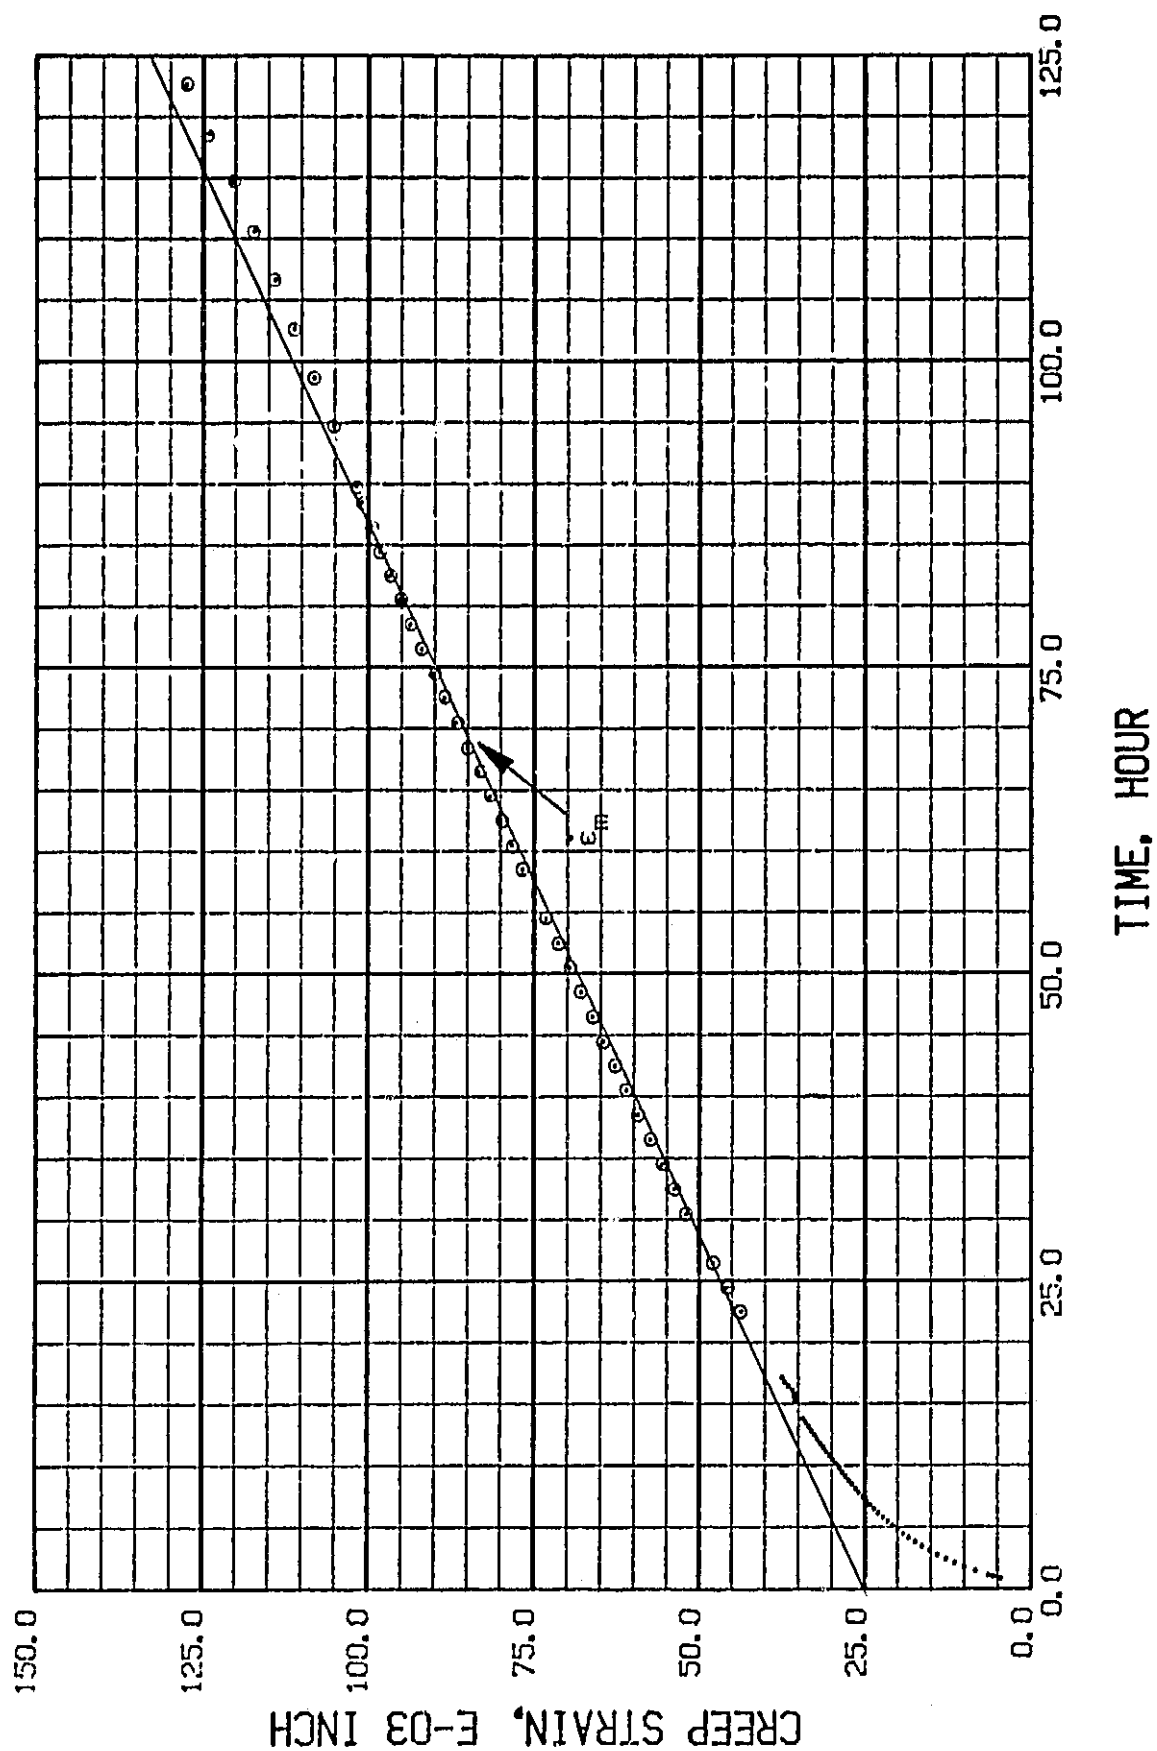
TEST H14 HS-31 760C./235MPa 15MPa H2

Figure 16. Creep strain-time curve for HS-31 tested at 760°C in 15 MPa H₂. Intermediate range plot to determine the minimum creep rate.

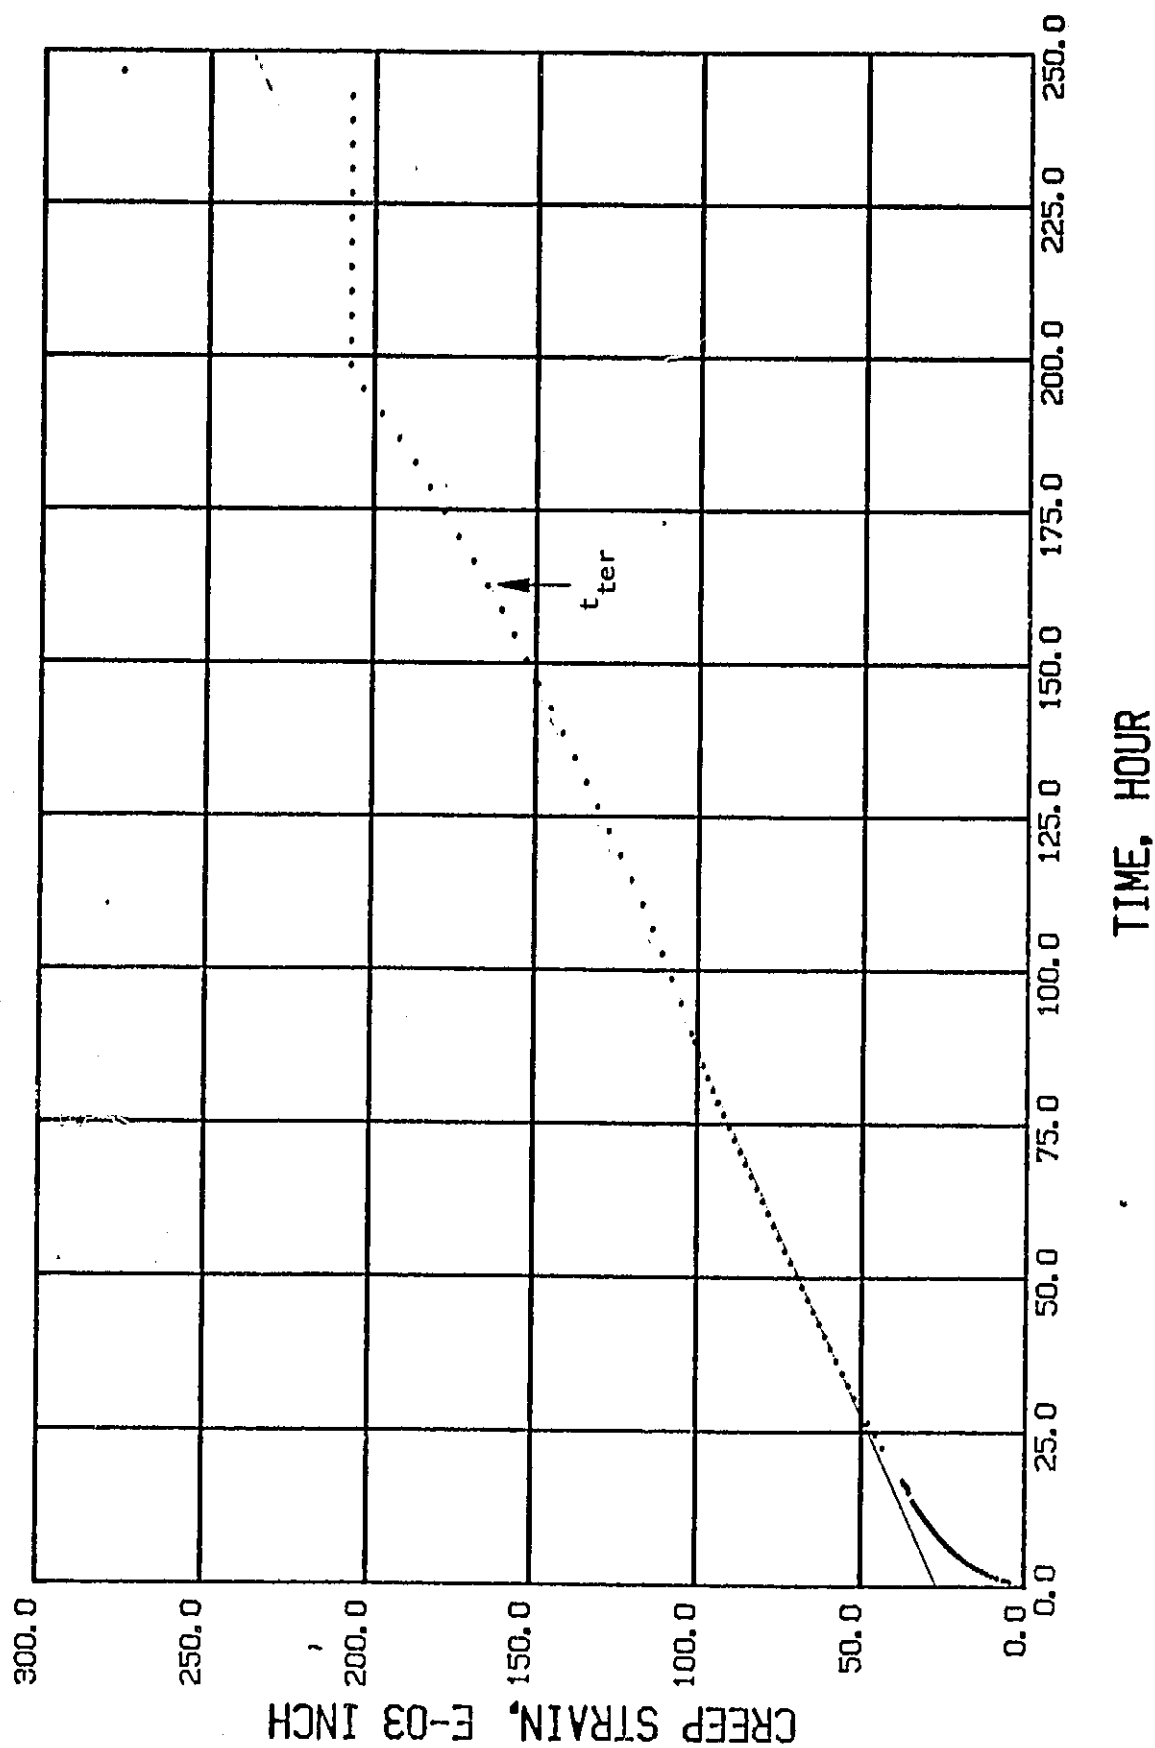
TEST H14 HS-31 760C./235MPa 15MPa H2

Figure 17. Creep strain-time curve for HS-31 tested at 760°C in 15 MPa H₂. Complete curve, can be used to obtain time to onset of tertiary creep.

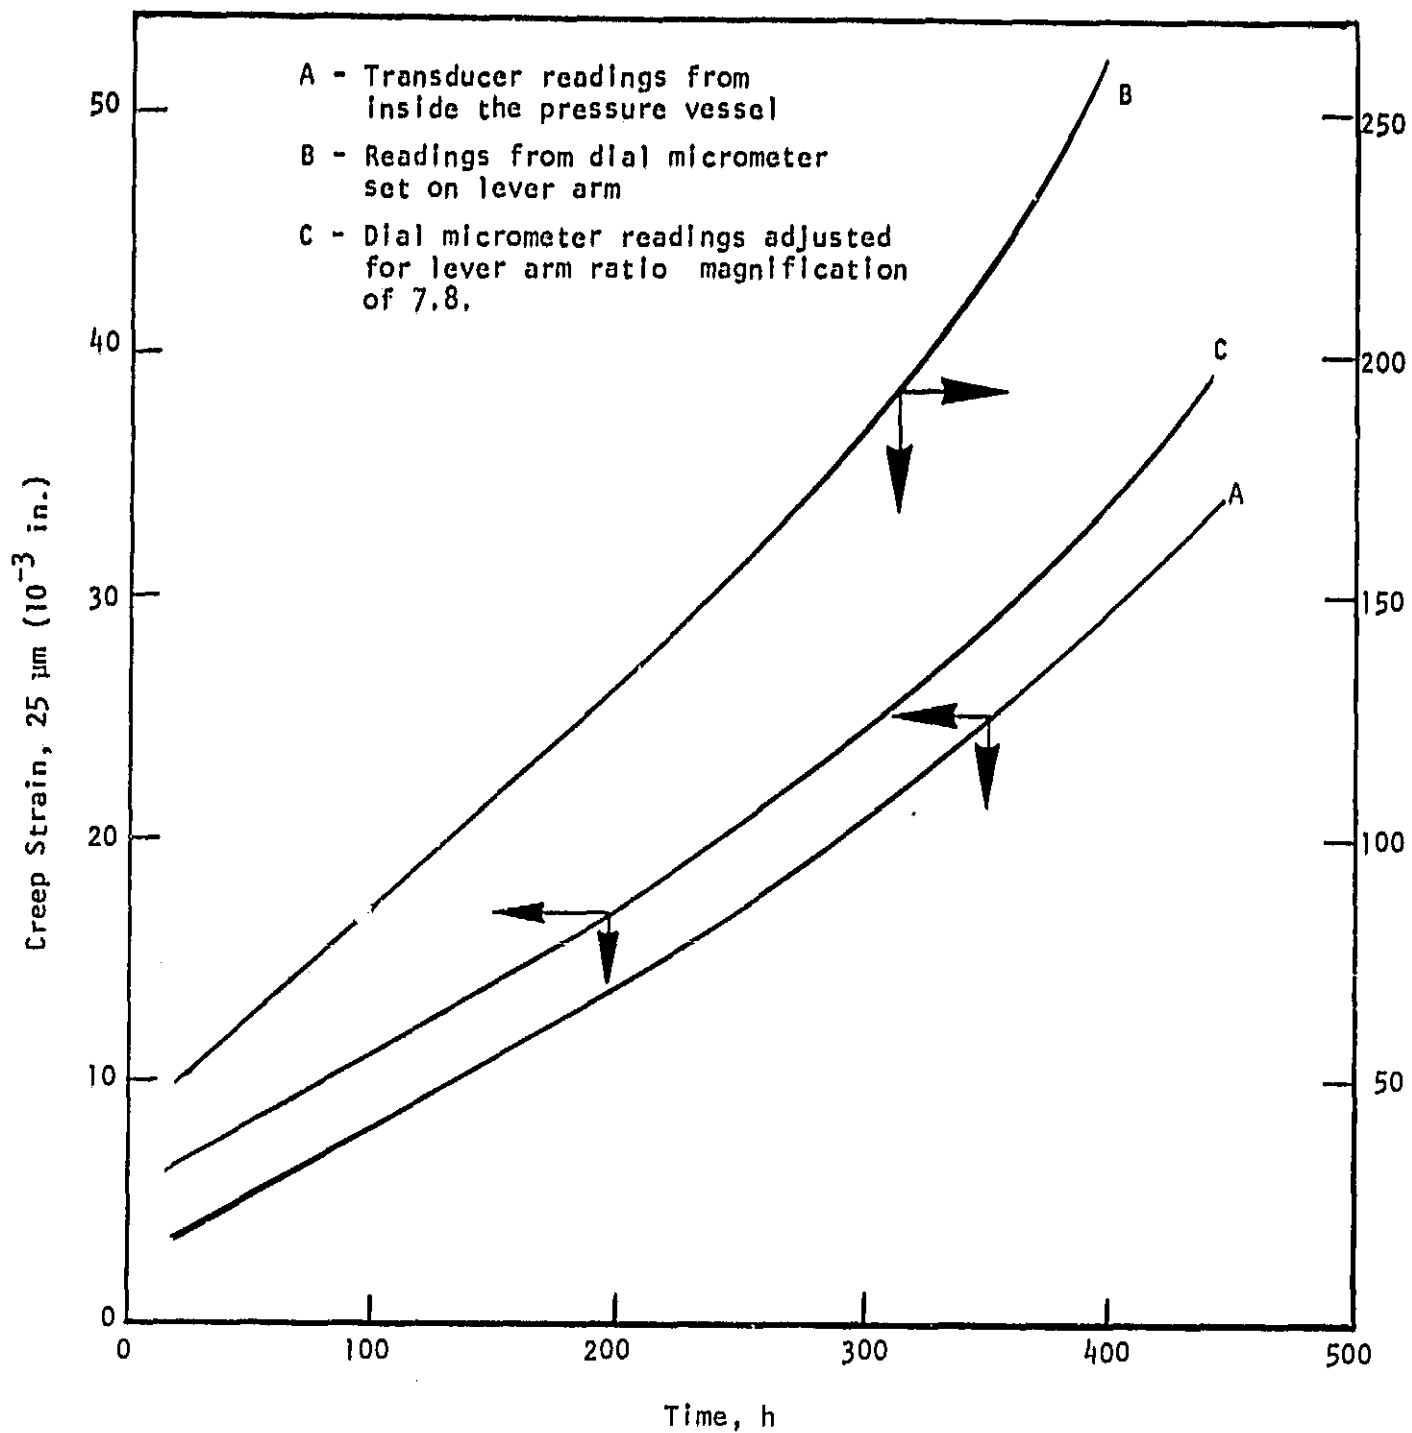
Curve A shows the transducer extension in $25 \mu\text{m}$ (10^{-3} in.) units. In curve B, the actual dial micrometer values are plotted in $25 \mu\text{m}$ (10^{-3} in.) units. And, in curve C, the data from curve B were reduced by a factor of 7.8 which is the lever arm ratio at the point on the loading arm where the dial micrometer was set in position. The lateral displacement between curves A and C indicates the difference in the initial setting values. The essential similarity between the curves provides the excellent agreement and reliability of the two measuring techniques with the external micrometer performing a continuous check on the internal transducer. It is to be noted that in most of the pressure creep experiments reported in the literature, the difficulties of internal strain measurement were avoided by the experimenters by solely relying on external measurements.

Figure B-1. Creep strain measurements for alloy SA-F11 at 760°C in 15 MPa H_2 (test H14).

During test H14, both the micrometer and transducer readings were compared and they agreed well. A plot of these readings for SA-F11 up to 445 h is shown in Fig. B-1.
